Minutes of **MIFFLIN TOWNSHIP BOARD OF TRUSTEES** Meeting

Held **December 26,** **2024**

The elected officials received correspondence from Columbia Gas of Ohio containing a notice of the proposed Agler Road (NCHP) pipeline project. (See attached.)

Figure 1: Agler Road NCHP Pipeline Project Route

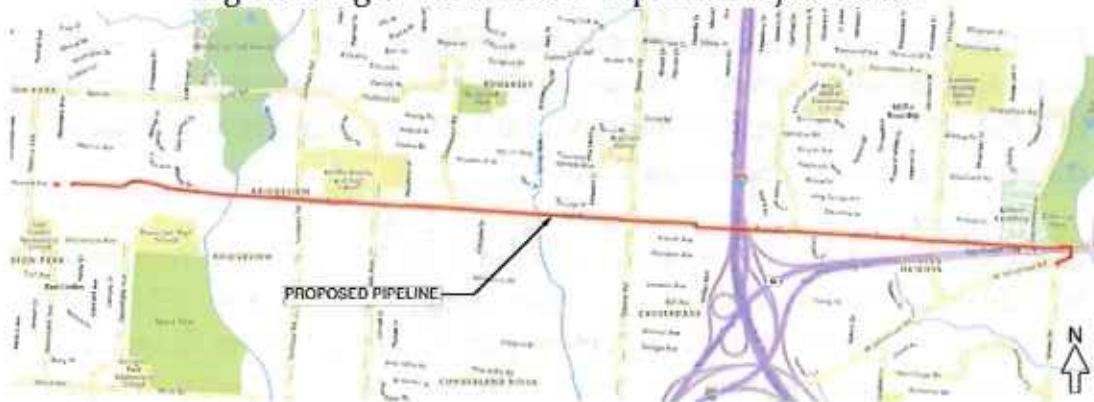
The map shown in Attachment A, Drawing Number AG-01: Overview Workspace illustrates the location of the Project in relation to existing transmission facilities in the Project area. The new pipeline is shown in red and the workspace for constructing the new pipeline is a black-dashed line. The existing NCHP pipeline that will be replaced is the blue line.

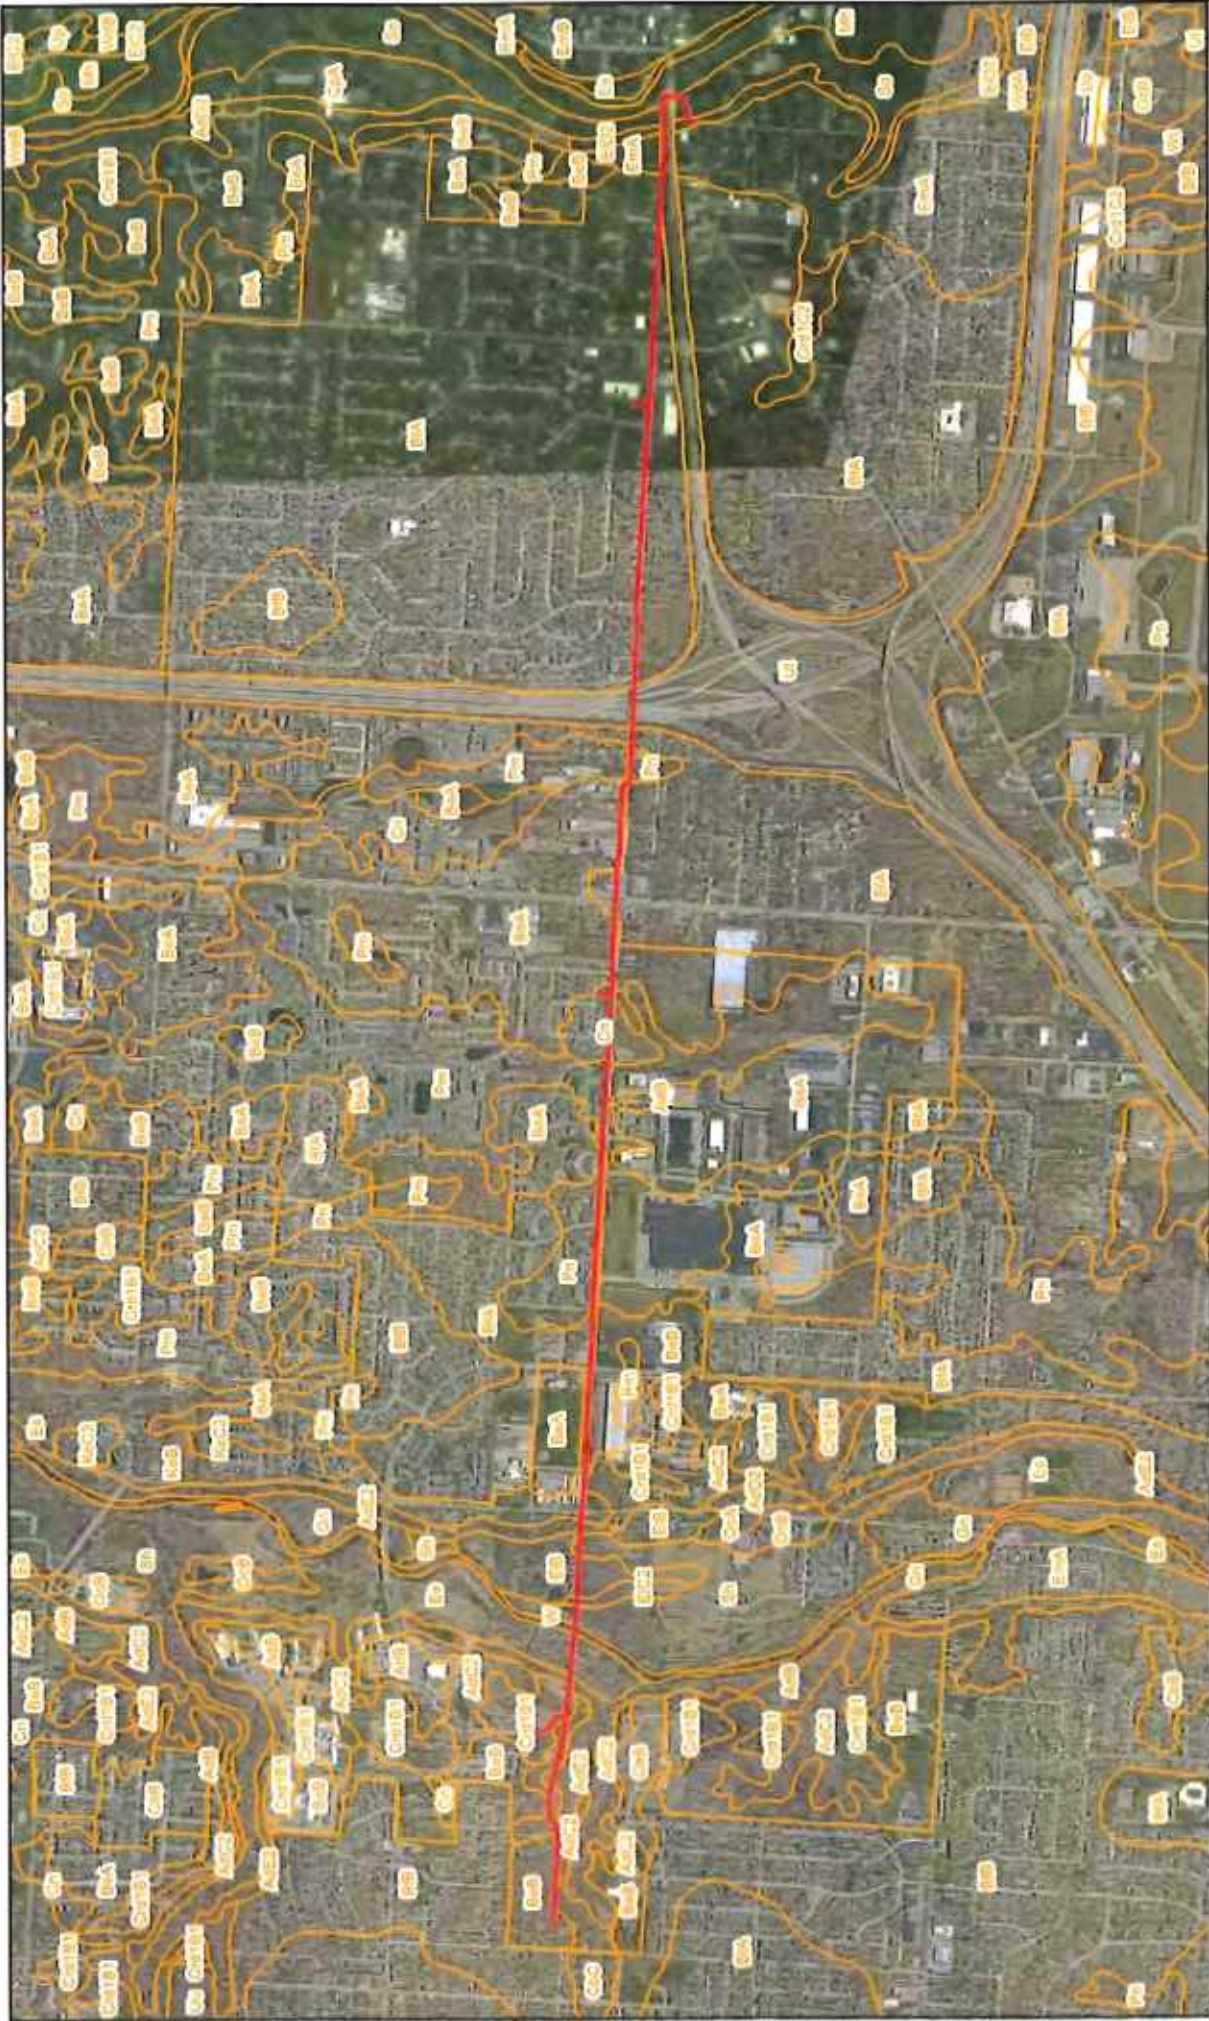
Figure 2

Soil Series Map

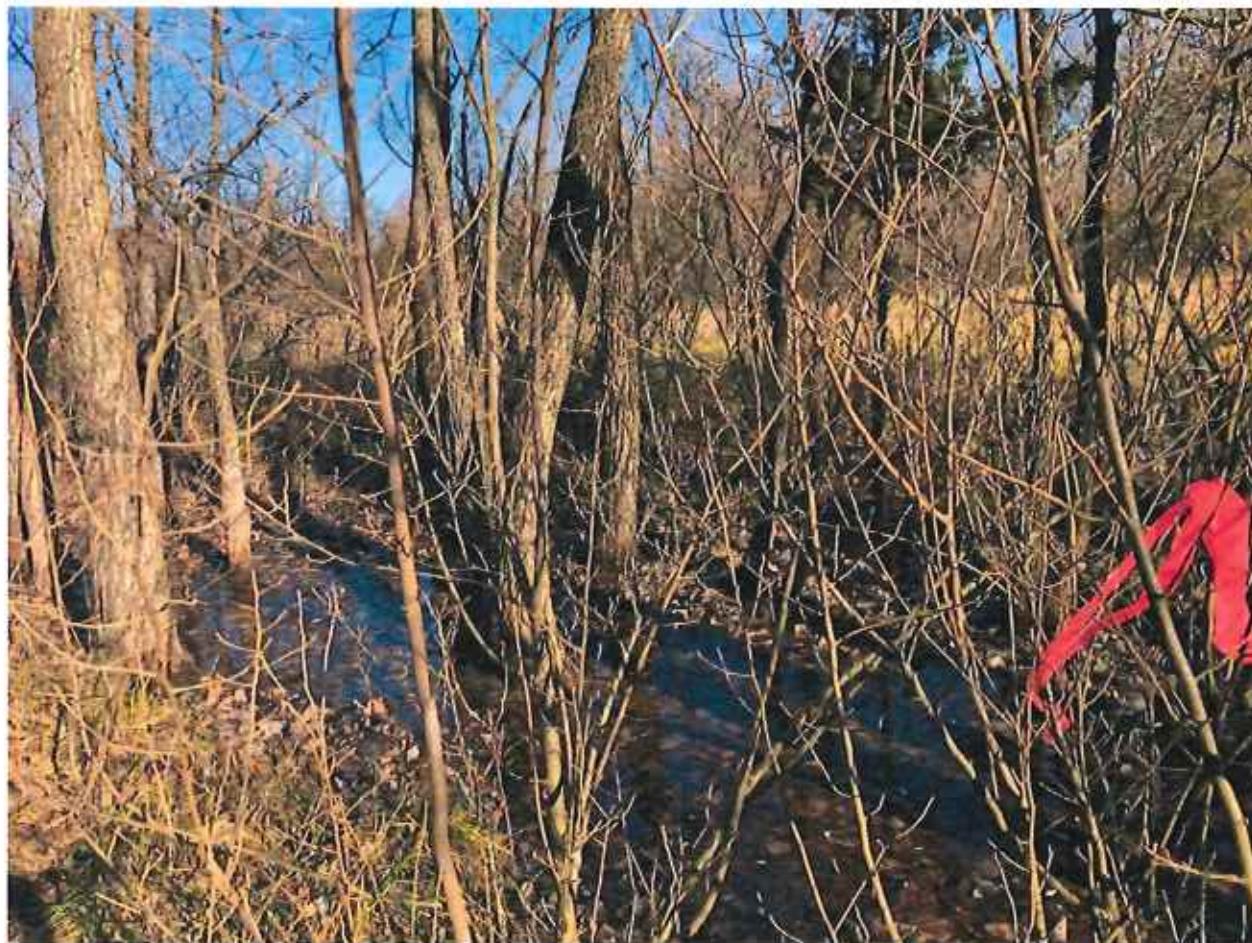
Photo #1 -Looking east at Wetland 8; near wetland flag W8.4

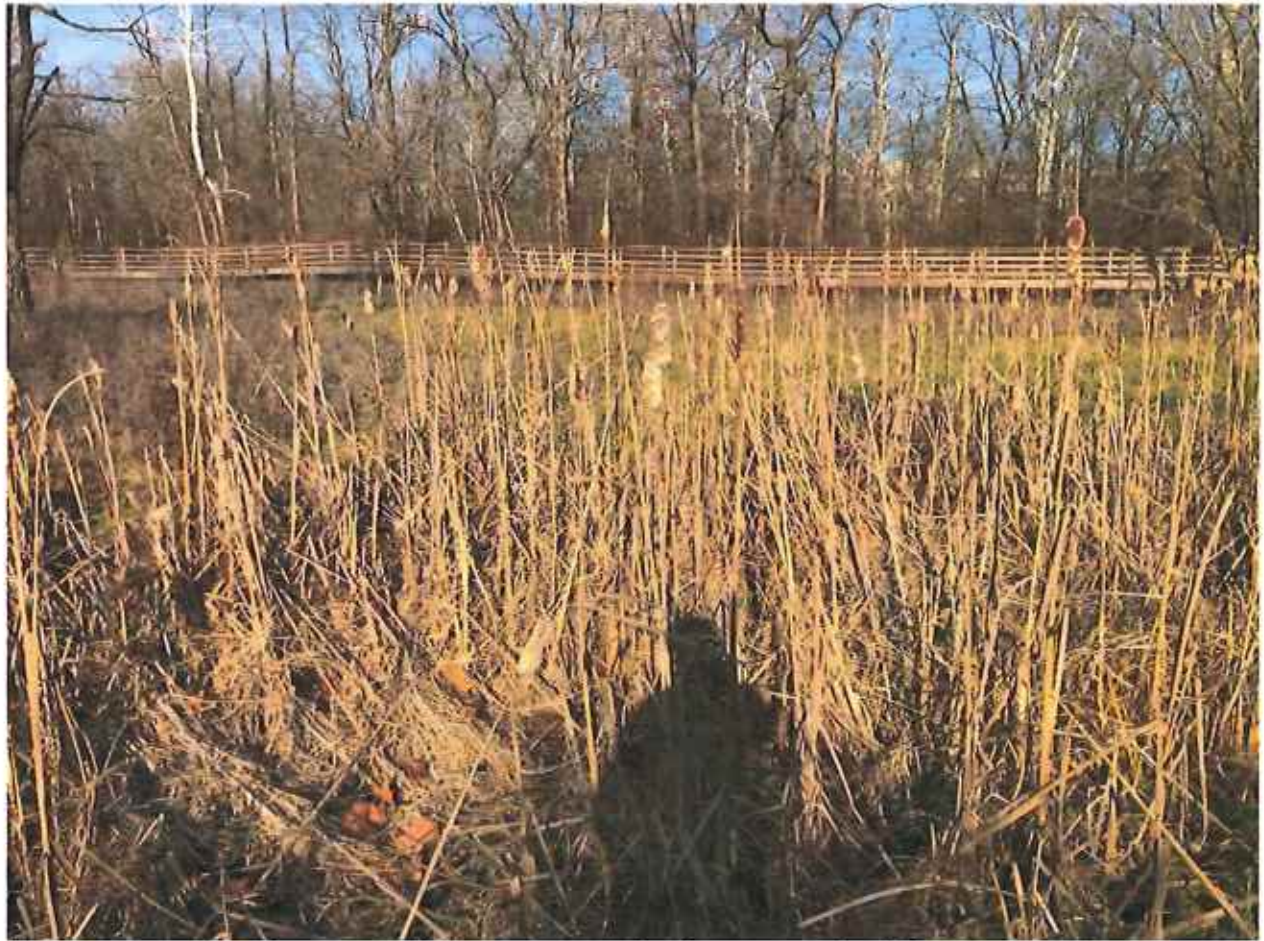
Photo #3: Looking north at Wetland 9; near wetland flag W9.5
